**DEPARTMENT OF TRANSPORTATION**

Contract #: 04-0120F4Cty: SF/ALA Rte: 80 PM: 13.2/13.9File #: 69.28**WELDING INSPECTION REPORT****Resident Engineer:**Pursell, Gary**Address:** 333 Burma Road**City:** Oakland, CA 94607**Report No:** WIR-013134**Date Inspected:** 29-Mar-2010**Project Name:** SAS Superstructure**OSM Arrival Time:** 700**Prime Contractor:** American Bridge/Fluor Enterprises, a JV**OSM Departure Time:** 1900**Contractor:** Zhenhua Port Machinery Company, Ltd (ZPMC), Changxing Island **Location:** Shanghai, China**CWI Name:****CWI Present:****Yes No****Inspected CWI report:** **Yes No N/A****Rod Oven in Use:** **Yes No N/A****Electrode to specification:** **Yes No N/A****Weld Procedures Followed:** **Yes No N/A****Qualified Welders:** **Yes No N/A****Verified Joint Fit-up:** **Yes No N/A****Approved Drawings:** **Yes No N/A****Approved WPS:** **Yes No N/A****Delayed / Cancelled:** **Yes No N/A****Bridge No:** 34-0006**Component:** OBG Trial Assembly**Summary of Items Observed:**

Segment 5BE (Punch List)

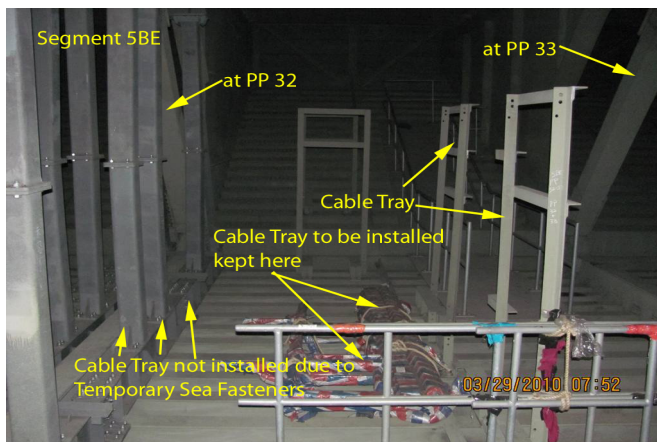
The QA inspector performed inspection on ZPMC Ship No. 17 against the punch list item 271 for Installation of Cable Tray Support Installation at various locations. It was observed that between Panel Point (PP) 32 and PP 33 the Cable Tray Supports were not installed due to interference with Temporary Sea Fasteners and kept on Bottom Panel T-Ribs for further installation at site.

Report forwarded to team leader for further action. Please refer the attached pictures for more comprehensive details.
